Saint Patrick Parish

John Canning & Co. assessed the conditions of the plaster in the attic space at Saint Patrick Parish.

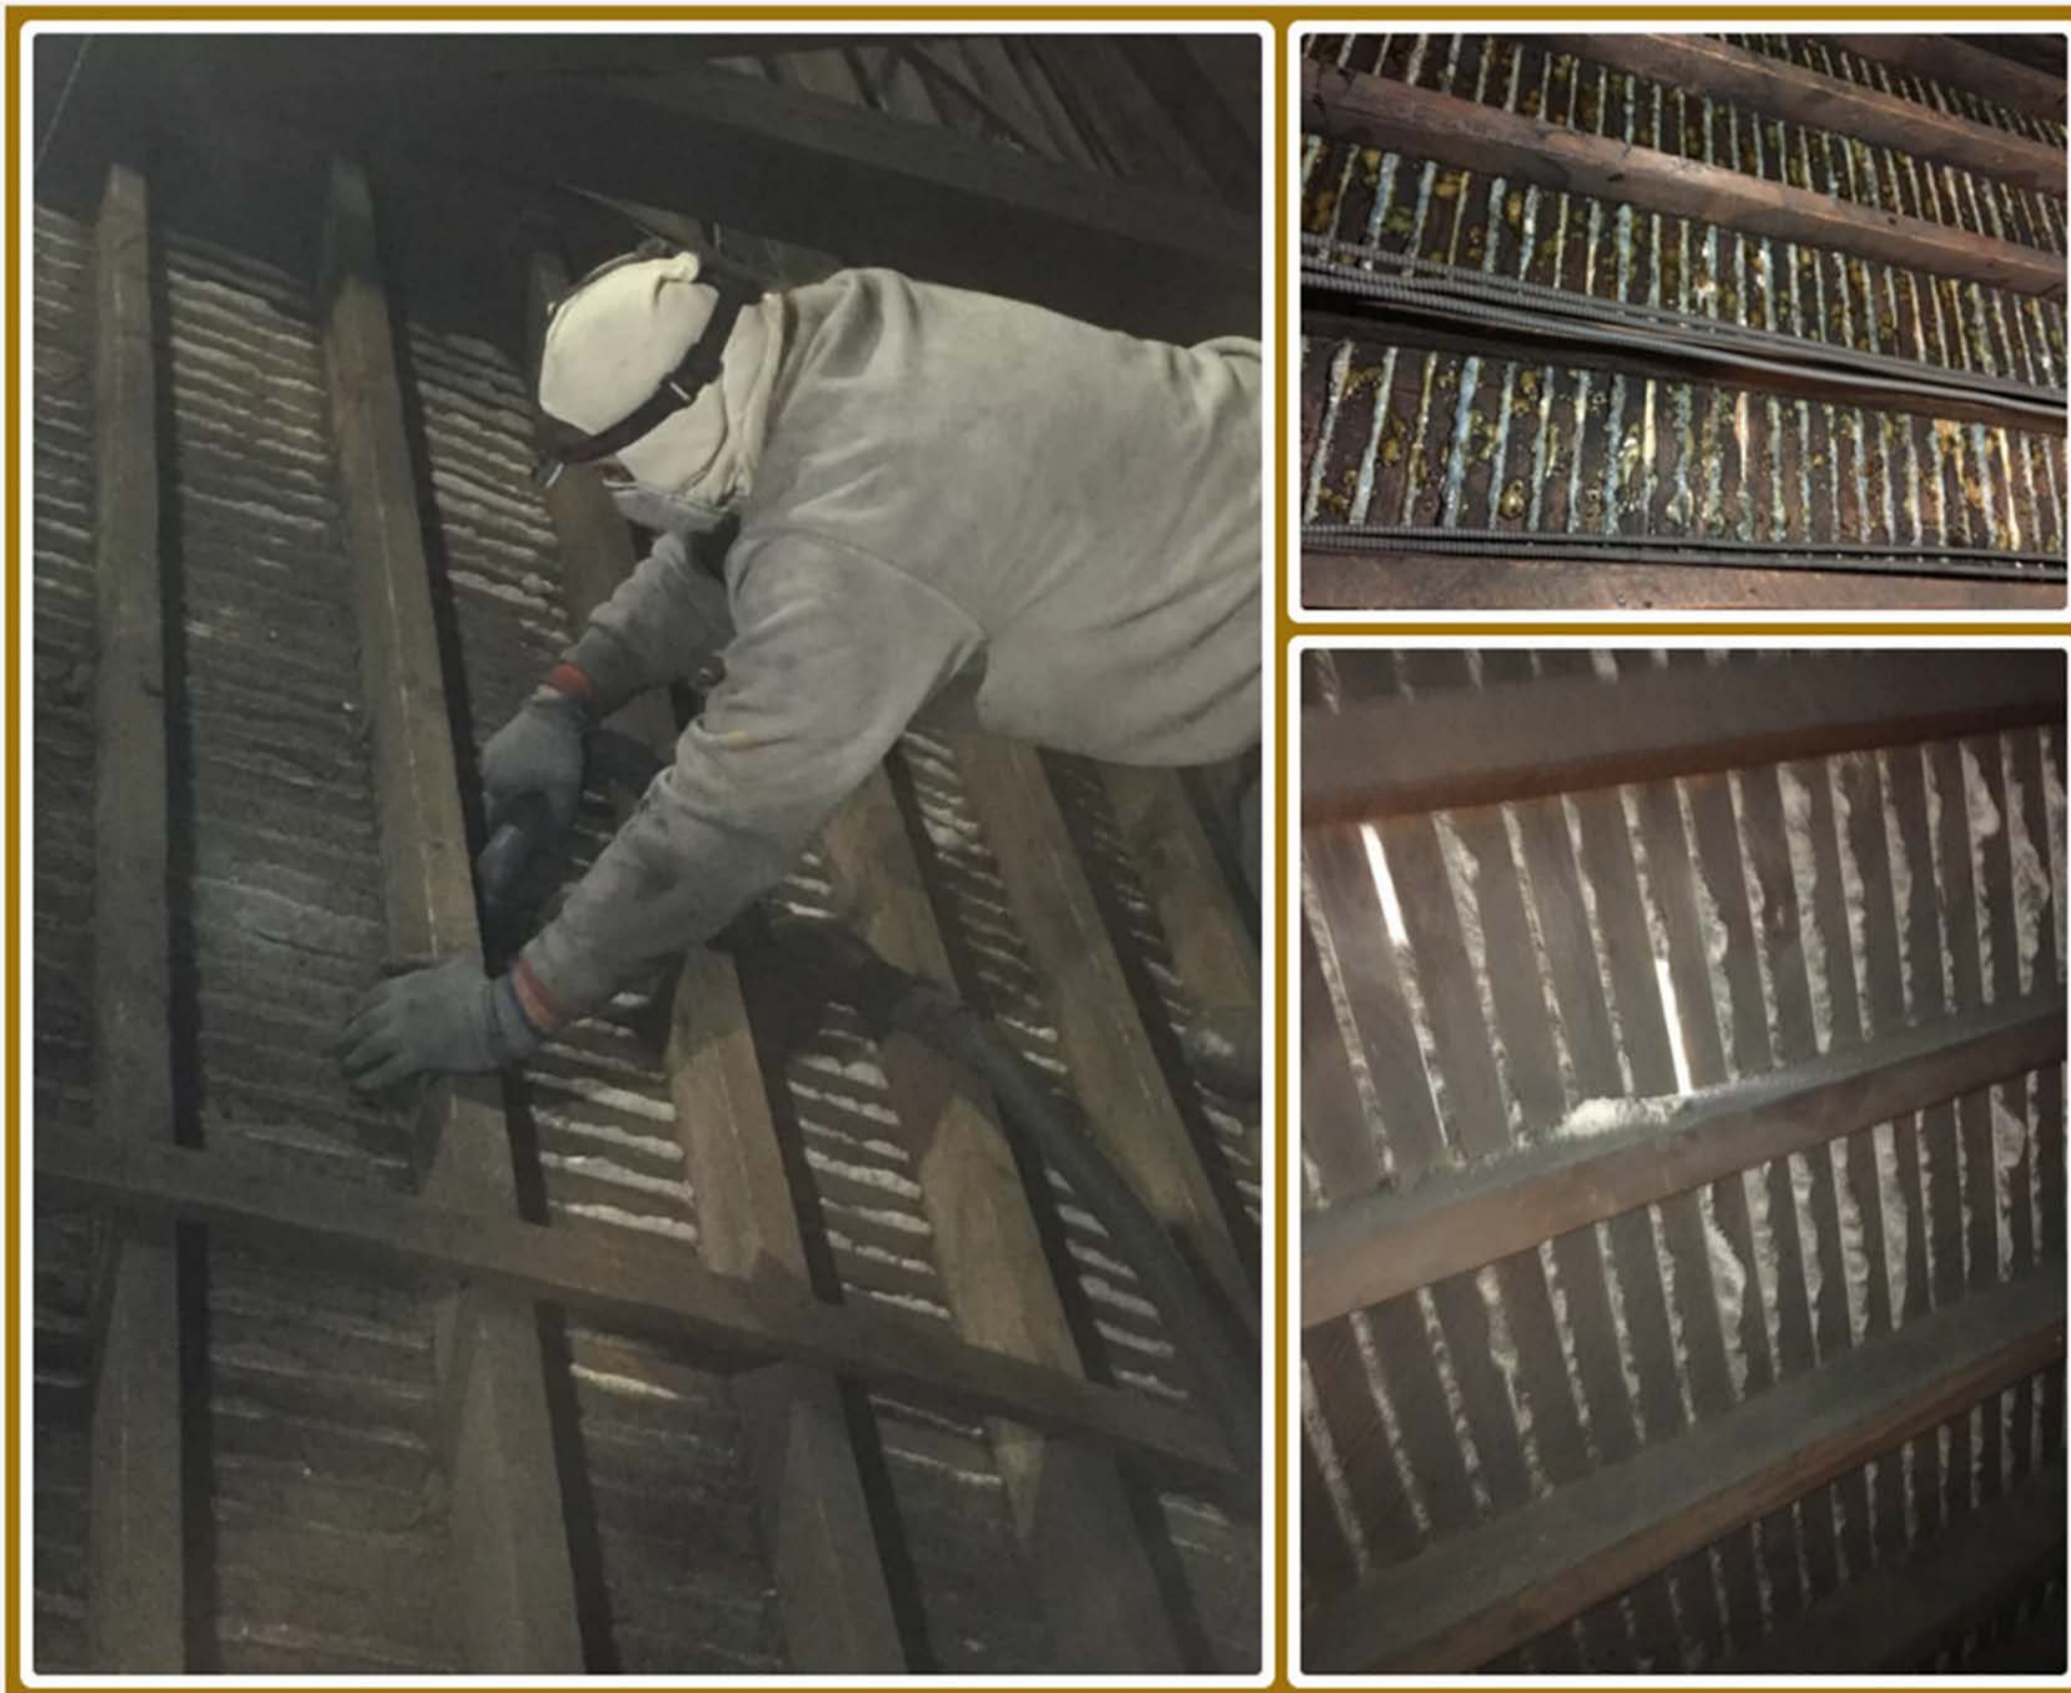
A portion of the historic plaster ceiling had collapsed. John Canning & Co. assessed the conditions of the plaster from the attic space and determined that, due to failing plaster keys, the plaster substrate was delaminating from the structural framing. The entirety of the plaster ceiling was consolidated from above using an adhesive injection system to stabilize and reinforce the plaster ceiling back to the supporting lath and framing. In areas where necessary, metal lath was installed to provide further structural reinforcement.
