## 2101 Connecticut Ave.

John Canning & Co. restored and repaired the plaster of this Historic District Building.

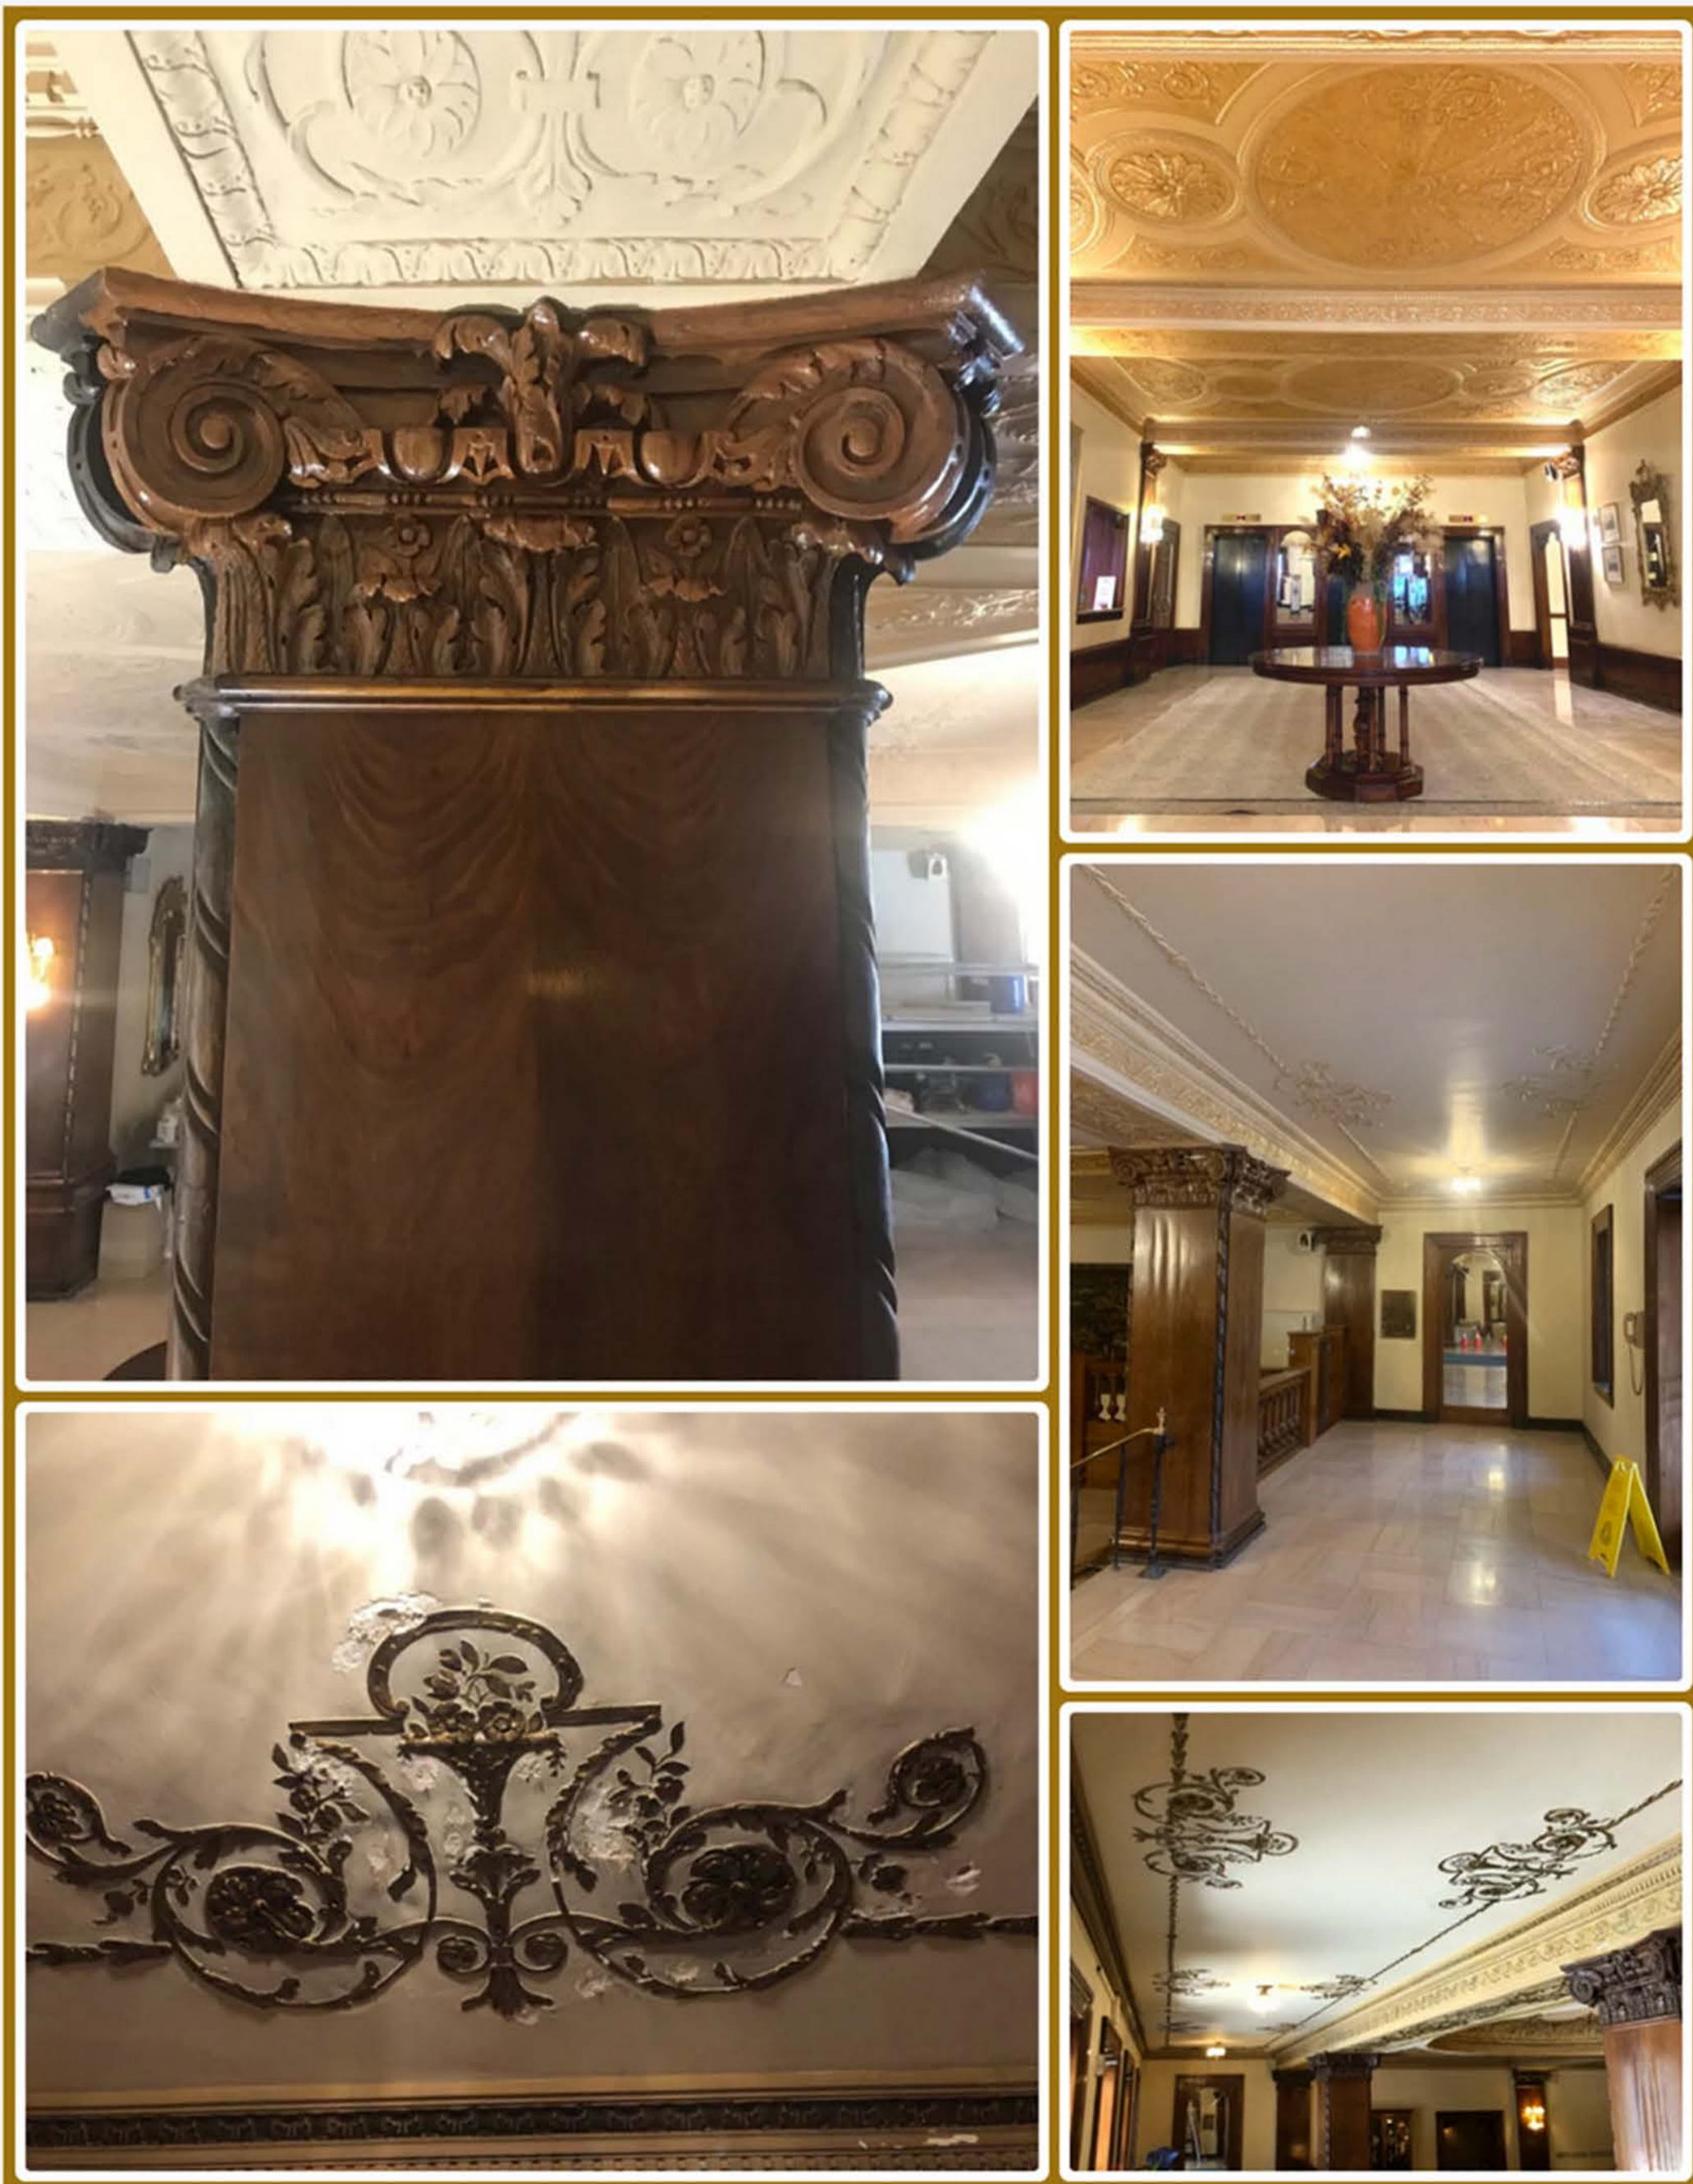
The lobby of 21010 Connecticut Ave. contains low-relief plaster ornamentation of classical scrolls, urns, and floral motifs. Water intrusion cause several areas of damage to the plaster and painted finish. The first phase of the project began in December of 2018 with a plaster survey to document and assess the conditions of the plaster and identify areas of failure. Paint analysis was also provided to identify the historic color scheme for reinstatement.

Over the years, finishes had been overpainted several times to a point where the details throughout the space were lost. Plaster restoration included removal of deteriorating plaster and repairs to the flat and ornamental features. Ornamental plaster was replicated using traditional mold making techniques and reinstalled to integrate with the historic elements. The delicate details were highlighted in metallic finish and glazed to further accentuate the details of the relief. Plaster column capitals throughout the space were woodgrained match the wood shafts below.
