Garrett Hall, University of Virginia

John Canning & Co.'s challenge at Garrett Hall involved reattaching and stabilizing plaster and creating a new ceiling and beam structure independent of the severely compromised building.

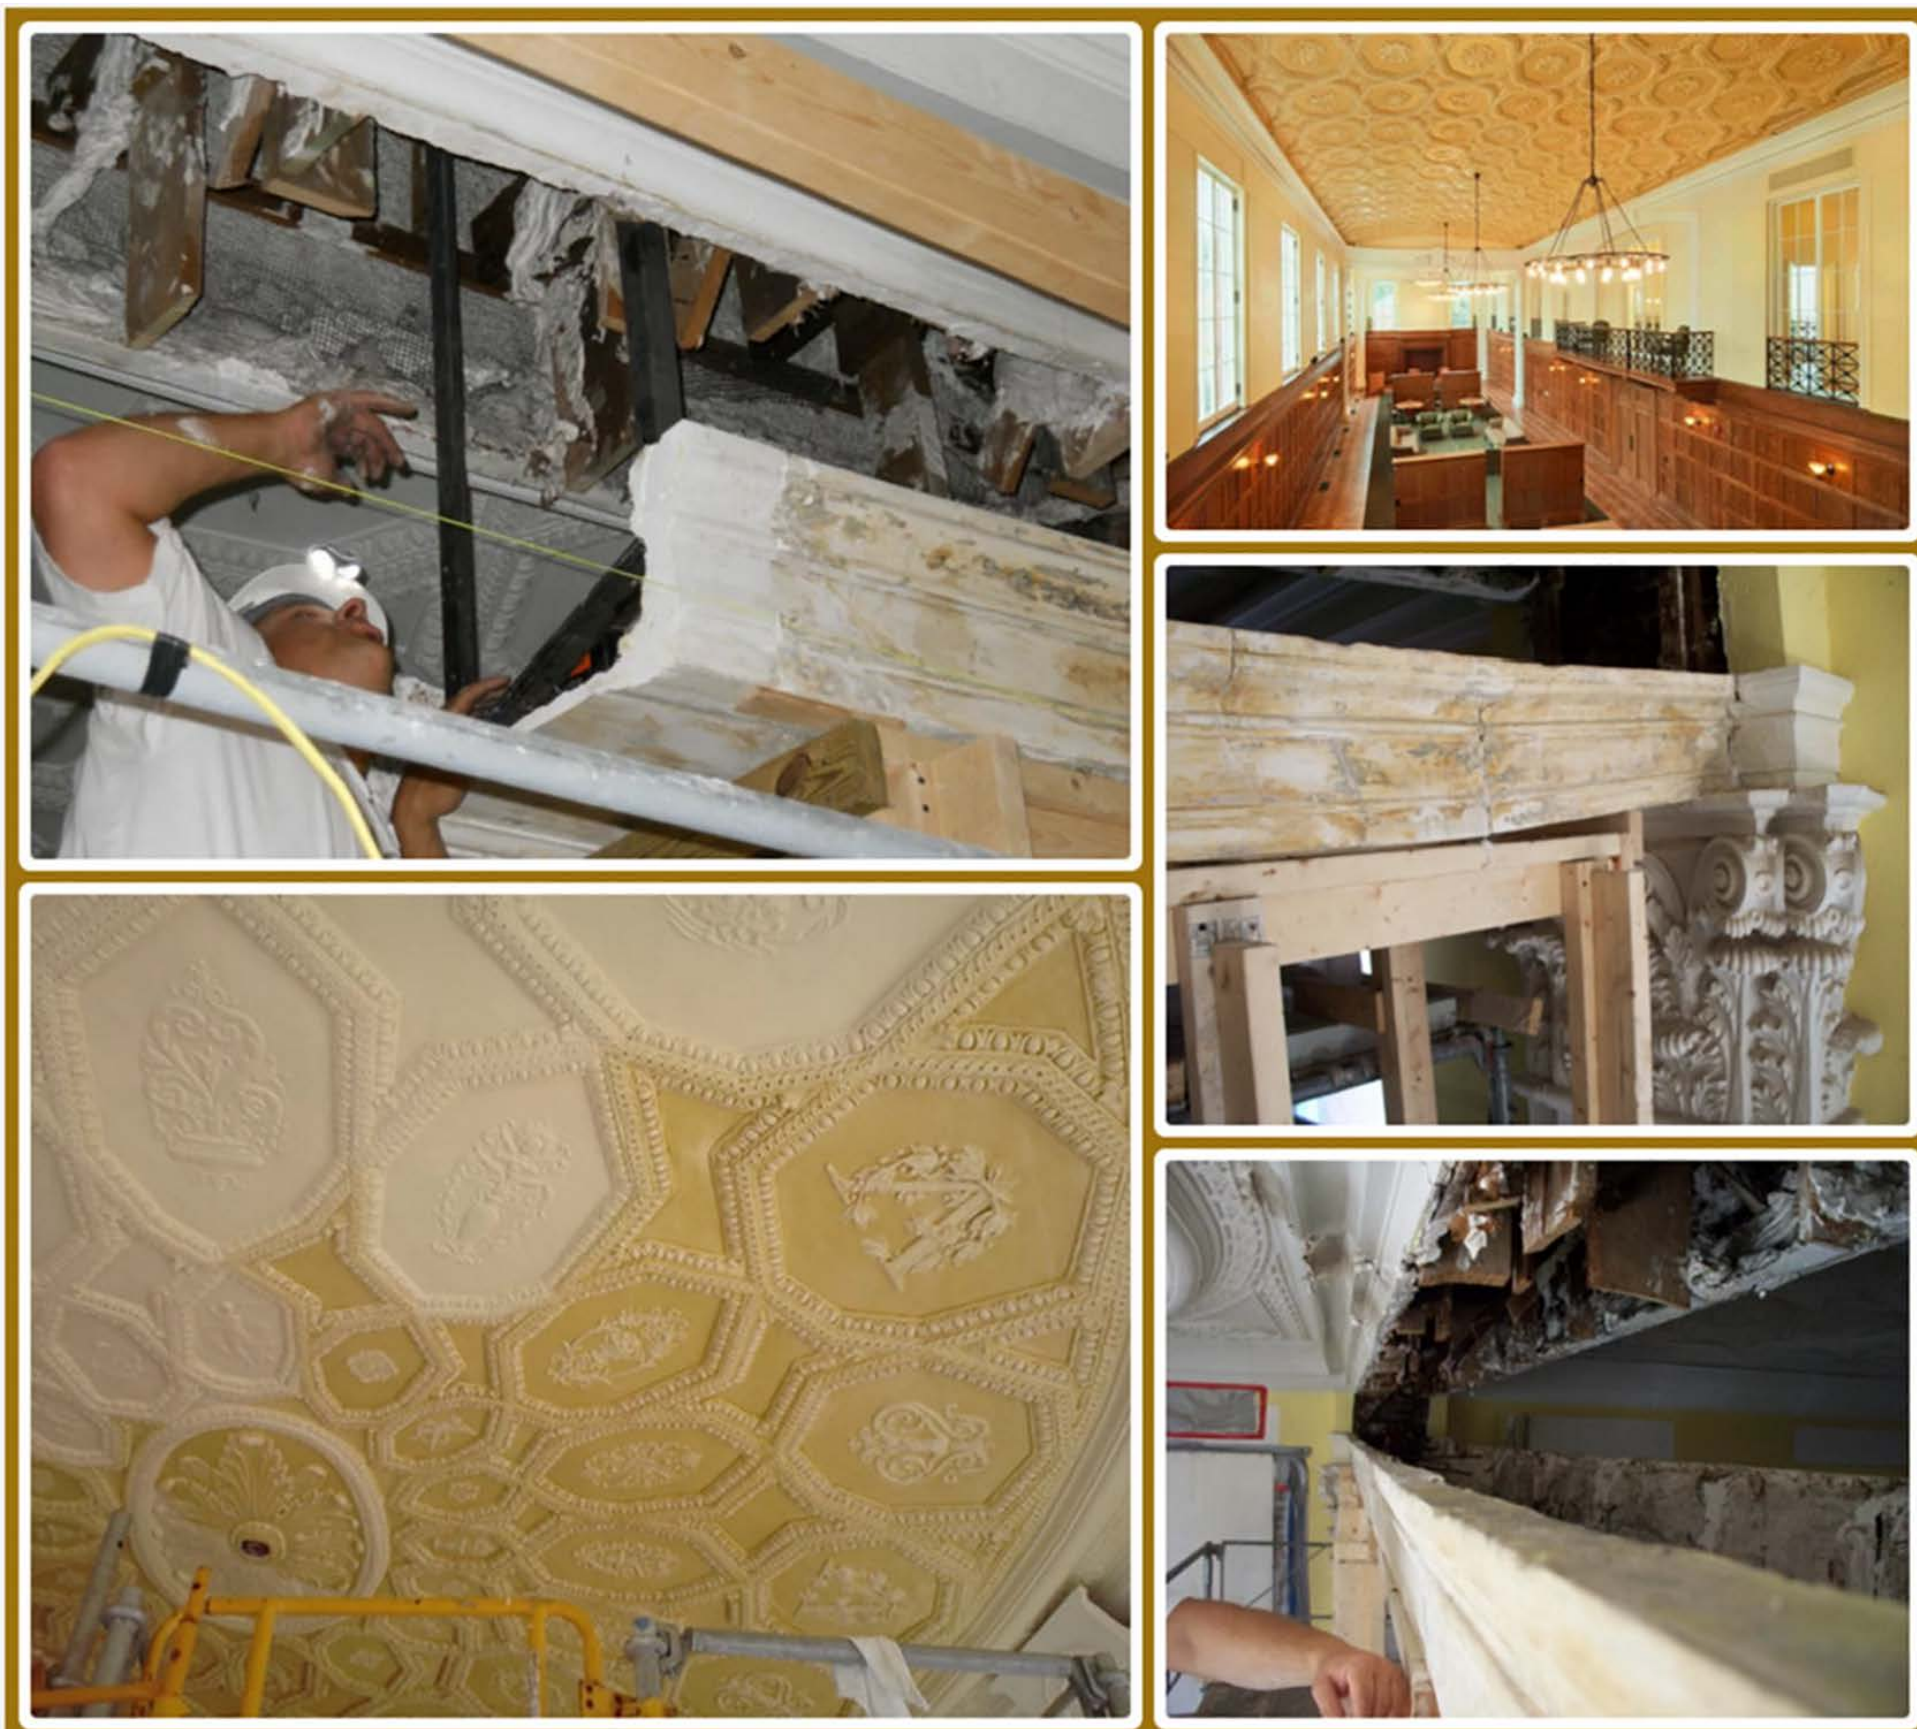
John Canning & Co. reattached the vaulted main dining room ceiling while also installing additional structural supports into the masonry and wood structure. We also fabricated and installed ornamental plaster, selectively removed large sections of plaster beams, pilasters, and other elements to access the structure for the purposes of adding steel and wood supports. This was followed with reinstalling the saved plaster pieces.
